## NEW MEXICO ENVIRONMENT DEPARTMENT

RE: Peabody Natural Resources Company, El Segundo Mine, Minor Non-Municipal Individual Permit; SIC 1221; NPDES Compliance Evaluation Inspection; NPDES NM0030996; July 16, 2019

#### **NPDES Compliance Inspection Report**

# EL Segundo Mine Peabody Natural Resources Company Compliance Evaluation Inspection NPDES Permit No. NM0030996 July 16, 2019

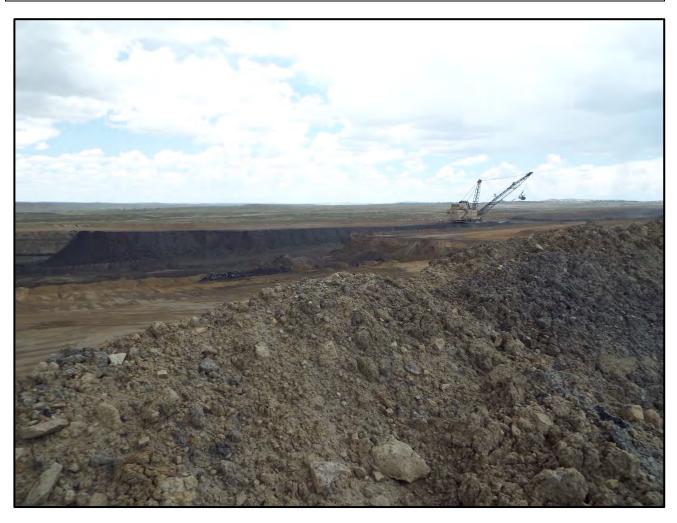
Photographer: Daniel Valenta	Date: 7/16/2019	Time: 1306			
City/County: 35 miles north of Milan, in Grants, McKinley County					
Location: Peabody Natural Resources Company, El Segundo Mine					
Subject: Shovel removes overburden from coal seam.

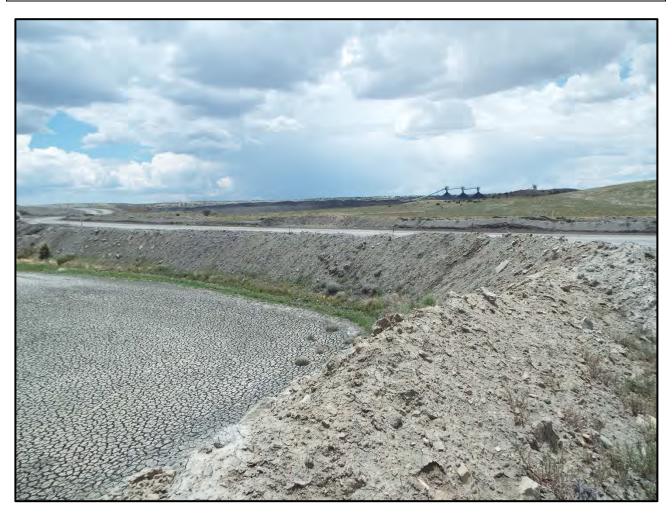
Photographer: Daniel Valenta	Date: 7/16/2019	Time: 1246			
City/County: 35 miles north of Milan, in Grants, McKinley County					
Location: Peabody Natural Resources Company, El Segundo Mine					
Subject: Internal containment pond to capture rain events. Coal loading area in background.

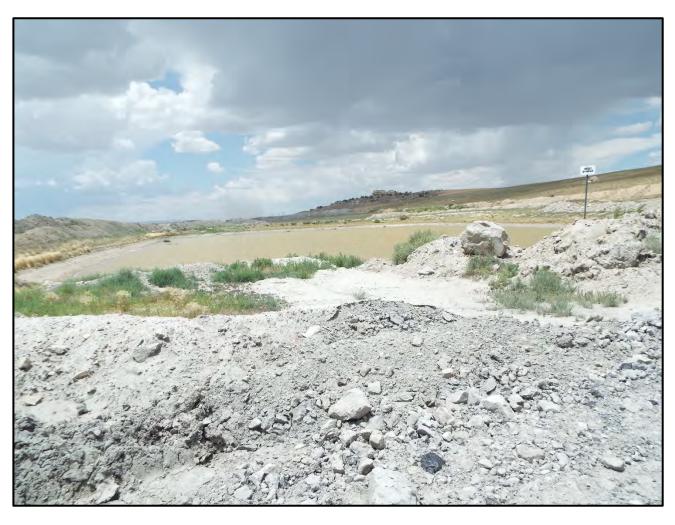
Photographer: Daniel Valenta	Date: 7/16/2019	Time: 1259			
City/County: 35 miles north of Milan, in Grants, McKinley County					
Location: Peabody Natural Resources Company, El Segundo Mine					
Subject: Internal containment pond to capture rain events.

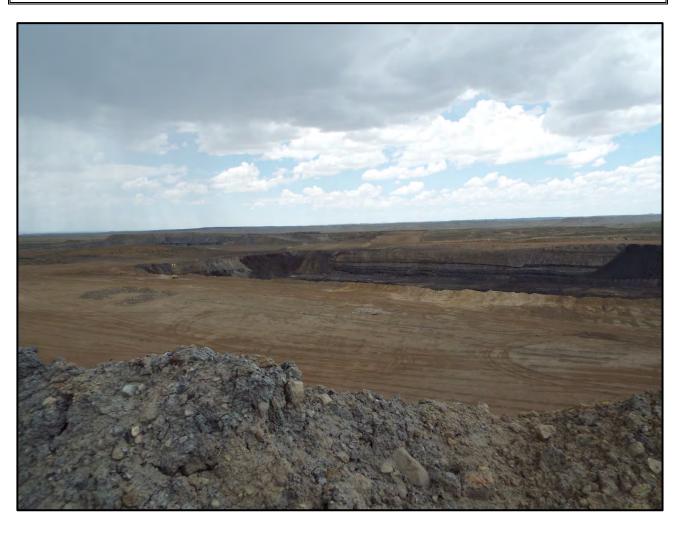
Photographer: Daniel Valenta	Date: 7/16/2019	Time: 1306			
City/County: 35 miles north of Milan, in Grants, McKinley County					
Location: Peabody Natural Resources Company, El Segundo Mine					
Subject: Front edge of mining activity. Overburden is being removed and coal seam mined with removed material then returned.

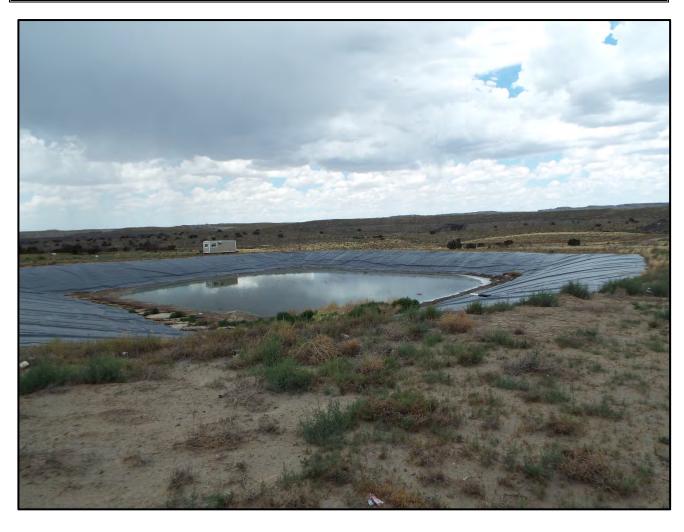
Photographer: Daniel Valenta	Date: 7/16/2019	Time: 1329				
City/County: 35 miles north of Milan, in Grants, McKinley County						
Location: Peabody Natural Resources Company, El Segundo Mine						
Subject: Sewage lagoon outfall 18. Lined lagoon captures treated wastewater discharge from facility.
